DRAFT
PHASE I ENVIRONMENTAL SITE ASSESSMENT
DISTRICT OF COLUMBIA PROPERTIES
POPLAR POINT, WASHINGTON, D.C.

PREPARED FOR THE
NATIONAL OCEANIC AND ATMOSPHERIC ADMINISTRATION

Prepared by
Ridolfi Engineers Inc.

May 17, 2002

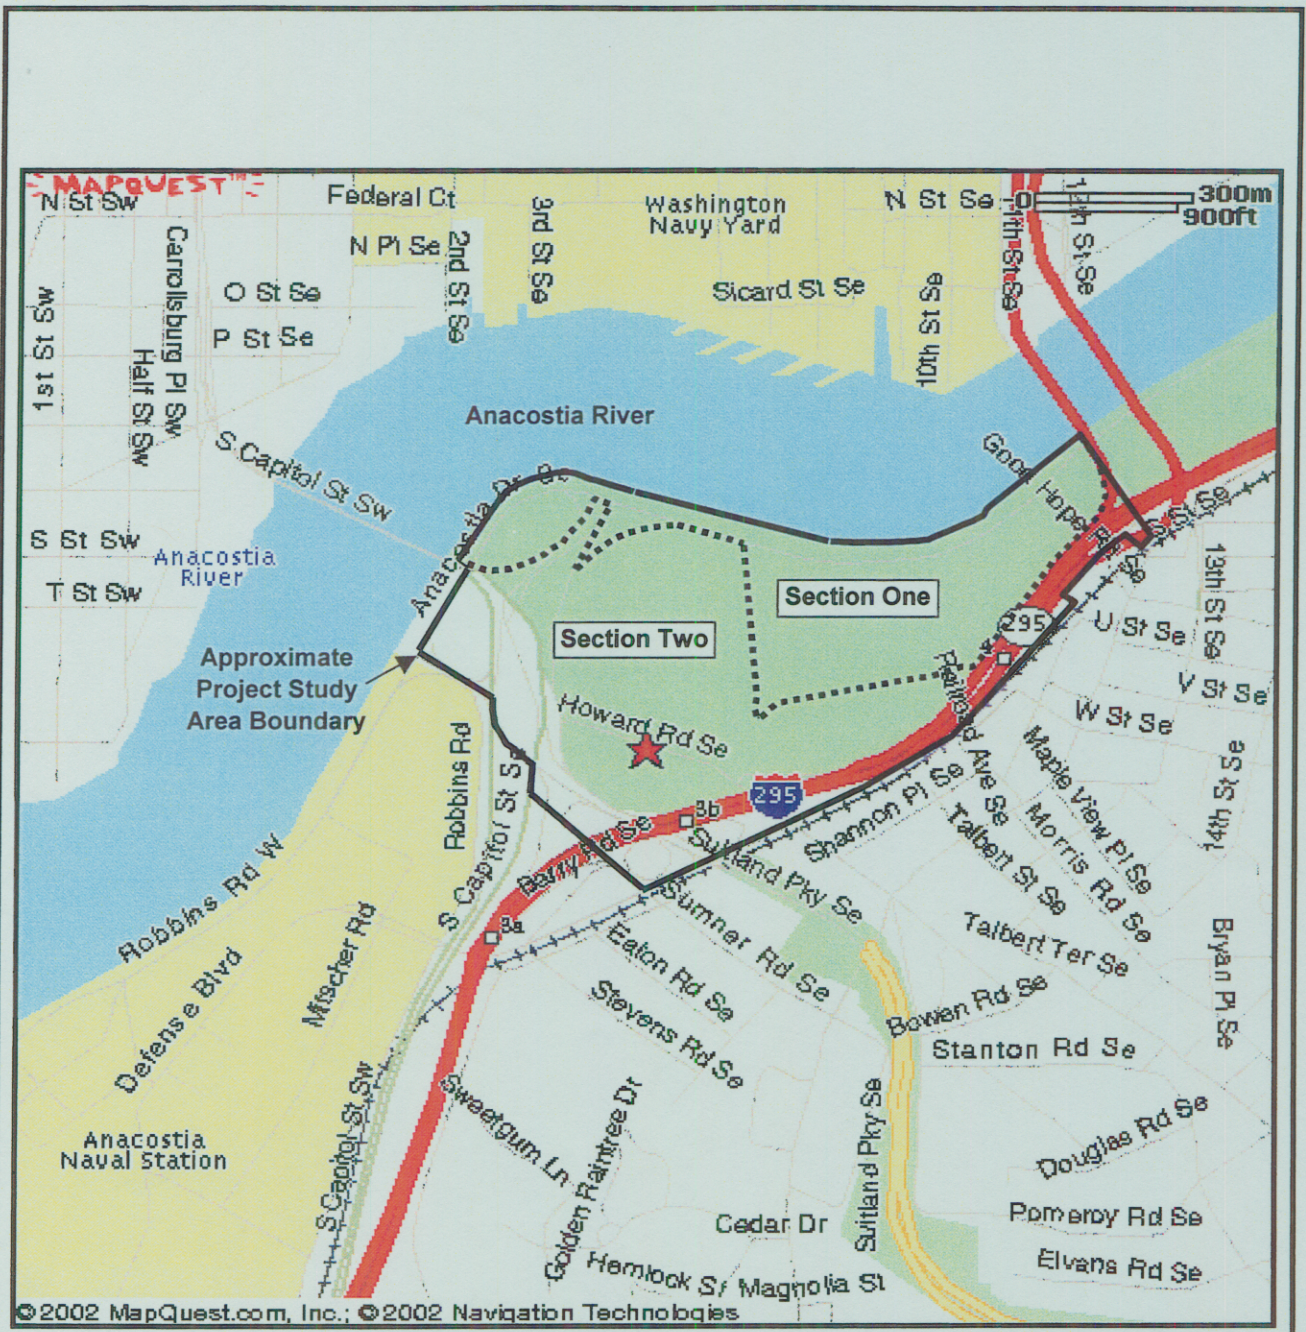
RIDOLFI ENGINEERS Inc.	Phase I ESA District of Columbia Properties Poplar Point, Washington, DC	16-May-02	Figure 1
	Prepared for National Oceanic and Atmospheric Administration	Project Study Area Location Diagram

The portion of Poplar Point that will be used for the restoration project, hereinafter referred to as the Project Study Area, consists of two sections (Section One and Two), which are depicted in the Project Study Area Location Diagram (Figure 1). Section One is primarily bounded by Anacostia Drive to the north, by Howard Rd. S.E. to the south, by southbound Interstate 295 to the south, and by South Capitol Street S.E. to the west. Section Two is bounded on the north by Section One and to the east by the Eleventh Street Bridge. The southern boundary runs along southbound Interstate 295 and Suitland Parkway. South Capitol Street S.E. and the Anacostia River form the western boundaries. The Properties assessed during this Phase I ESA are located within Section Two and are depicted in the District of Columbia Properties Locations Diagram (Figure 2). The majority of the twelve Properties are located near the intersection of Howard Road S.E. and Suitland Parkway.

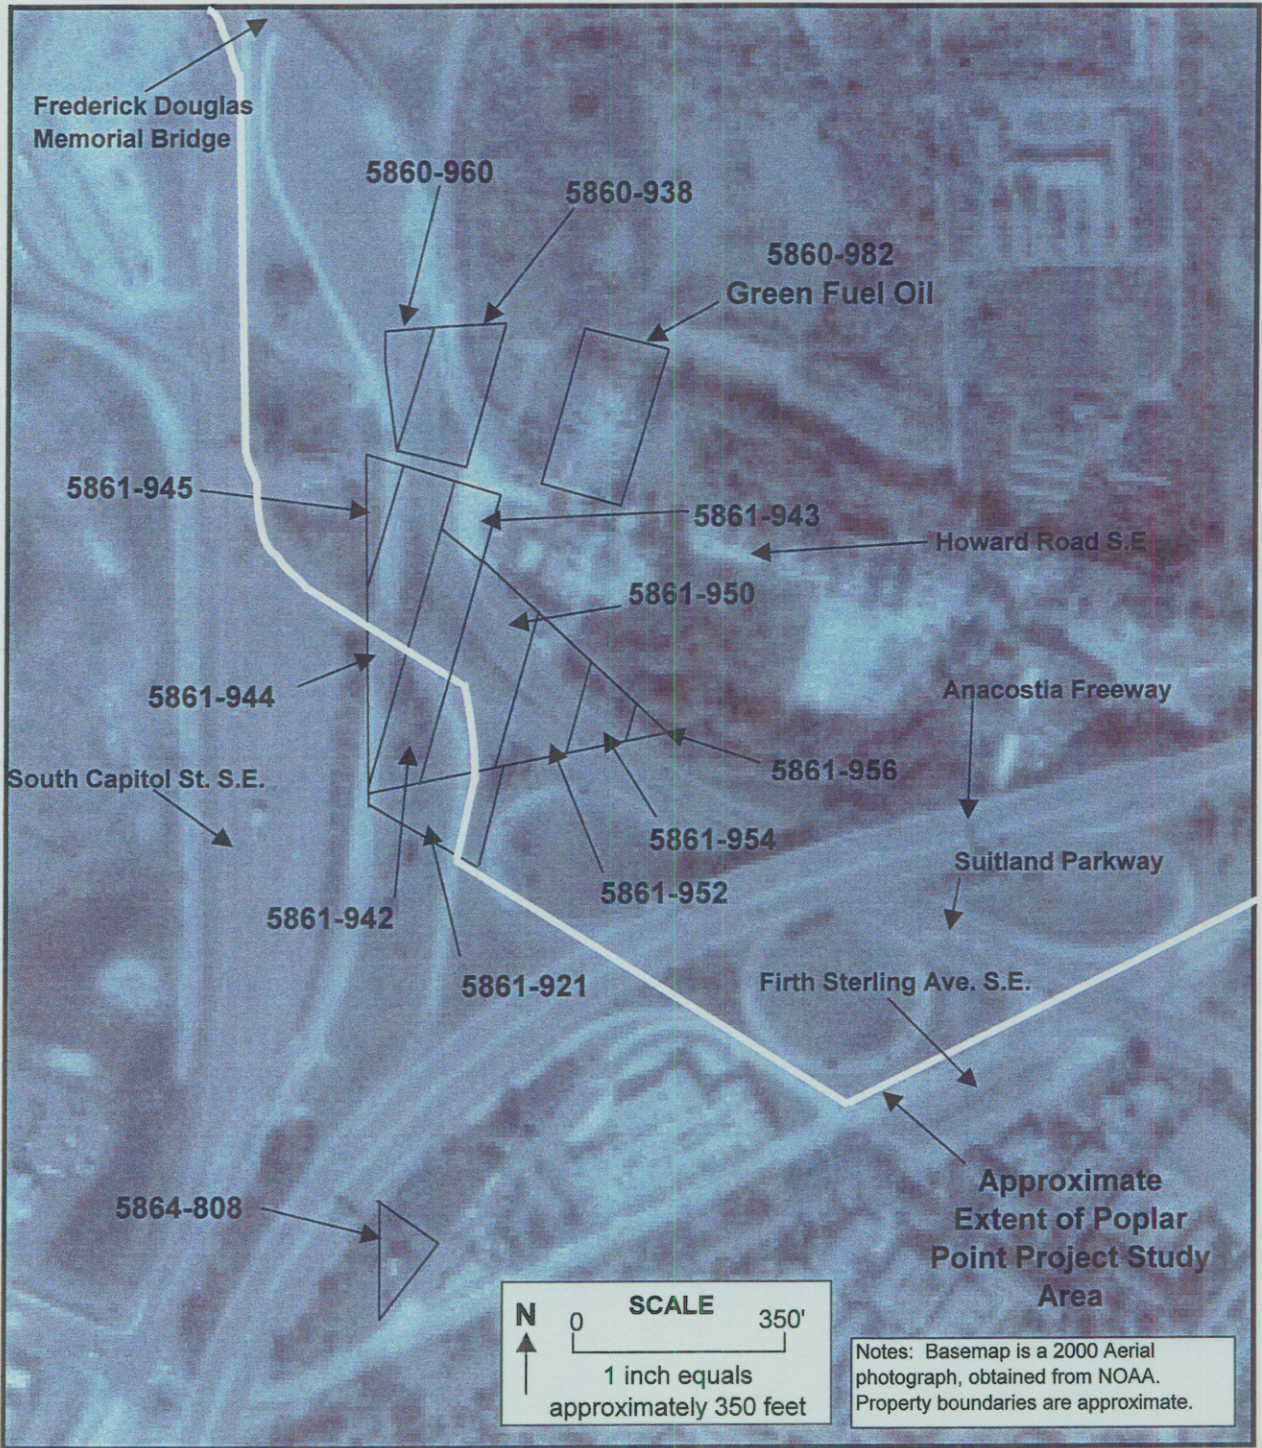
RIDOLFI ENGINEERS Inc.	Phase I ESA District of Columbia Properties Poplar Point, Washington, DC	13-May-02	Figure 2
	Prepared for National Oceanic and Atmospheric Administration	District of Columbia Properties Locations Diagram

Ridolfi reviewed aerial photographs of the Properties and surrounding area, dated 1957, 1970, 1980, and 1988, which were obtained from Environmental Data Resources, Inc. (EDR). The aerial photographs obtained from EDR are contained in Appendix B. Ridolfi reviewed aerial photographs dated 1918, 1942-43, 1949, 1955, 1957, 1959, 1963, 1973, 1978, 1985, 1990, 1994, and 2000, which were obtained from NOAA. The aerial photographs are described in Table 2. The 1918 aerial photograph was of poor quality, and no detailed observation of the Properties could be made. The 2000 aerial photograph depicting the Property and surrounding areas was used as a base map for the District of Columbia Properties Locations Diagram shown on Figure 2.

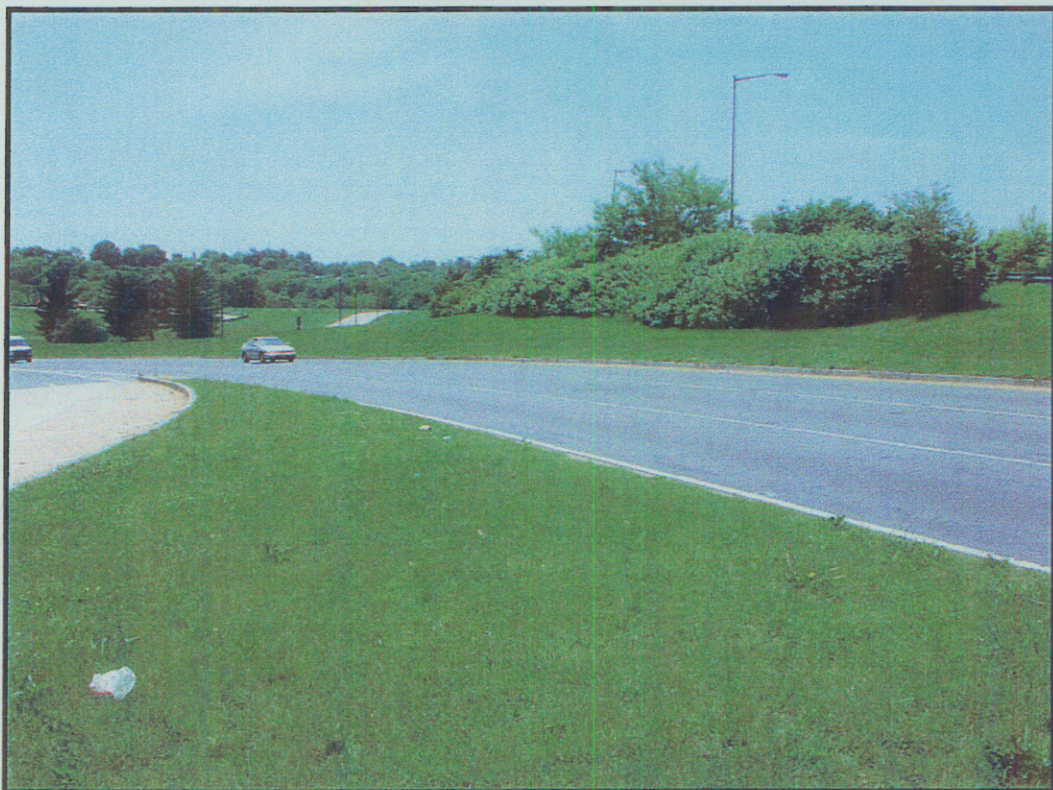
Photo 2: Overview of northern portions of 5861-942, 5861-943, 5861-944, and 5861-945, facing southwest. Note: Suitland Parkway on central portion of photograph.

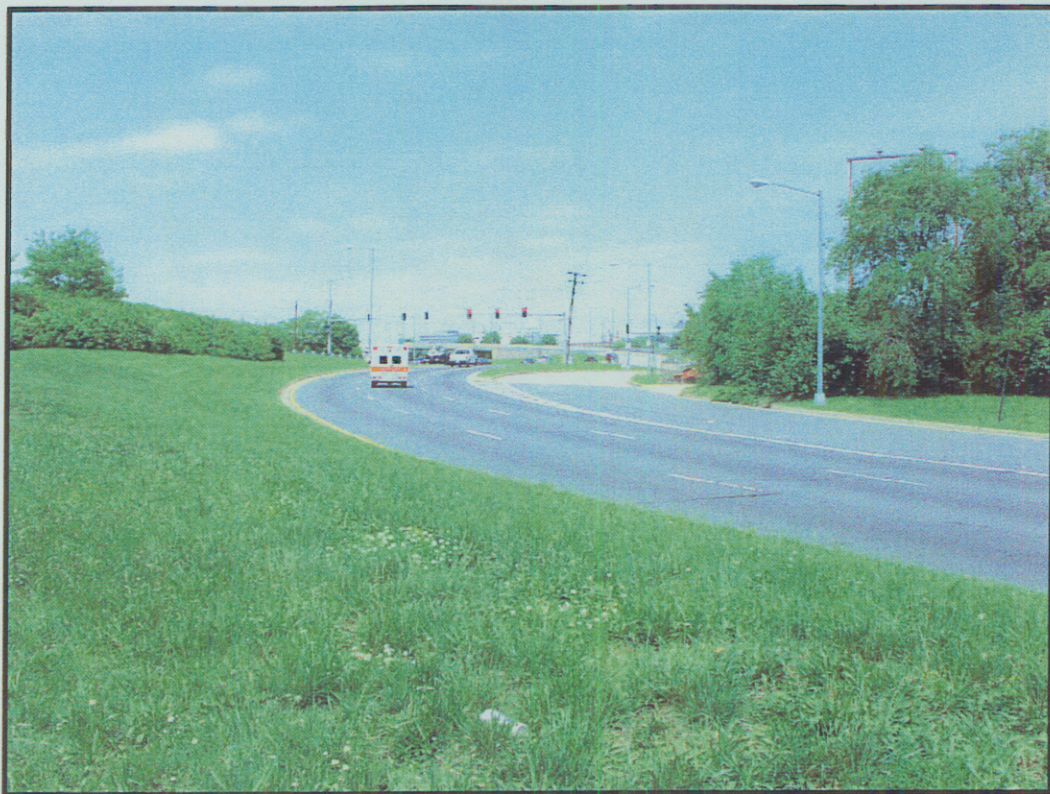
Photo 3: Overview of the southern portions of 5861-942, 5861-943, 5861-944, and 5861-945, facing northeast. Note: Suitland Parkway in central portion of photograph.

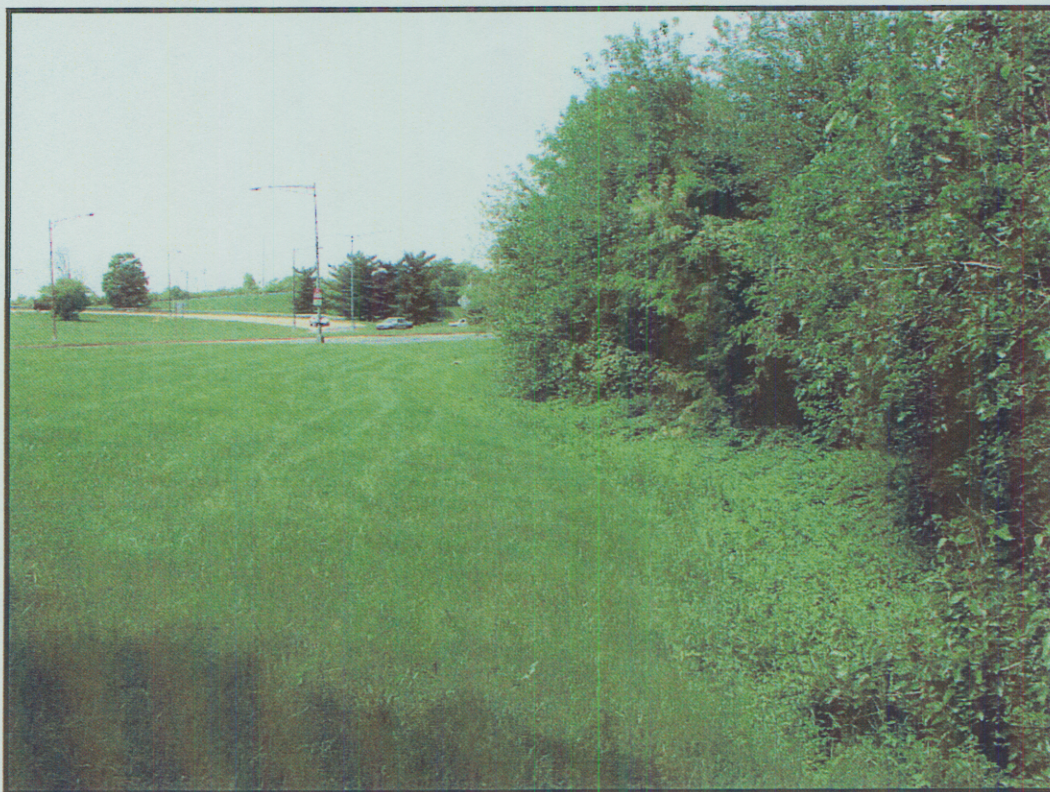
Photo 4: Overview 5861-956, 5861-954, and 5861-952, facing east.
